# Manhole Inspection Summary

Manhole # S33KK1023MH

**Location** Address: **4310 SAINT PAUL ST**

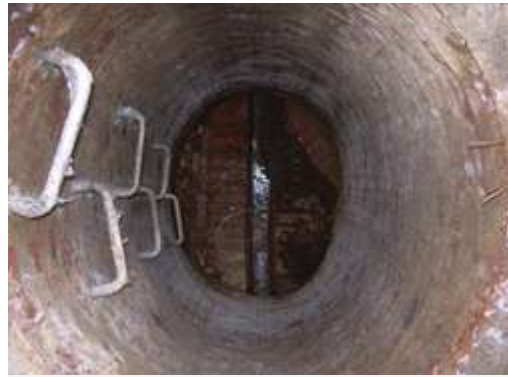
Top View

Evidence of surcharge - Bench debris.  
Channel debris.

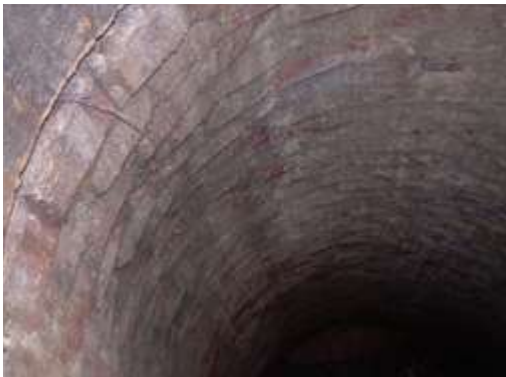
Defect

Frame leaks. Corbel root intrusion and  
infiltration. Barrel infiltration.

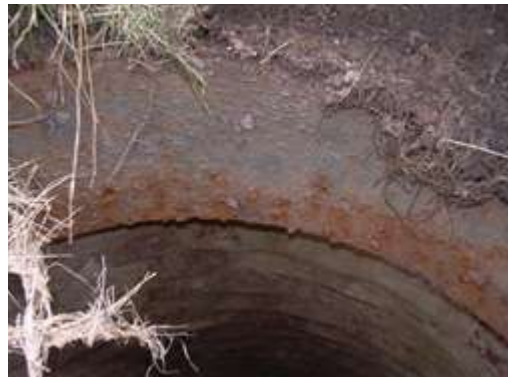
Defect

Frame leaks. Corbel infiltration.

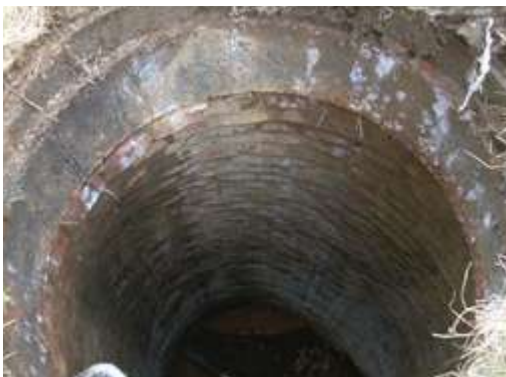
Defect

Frame leaks. Corbel root intrusion and  
infiltration. Barrel infiltration.

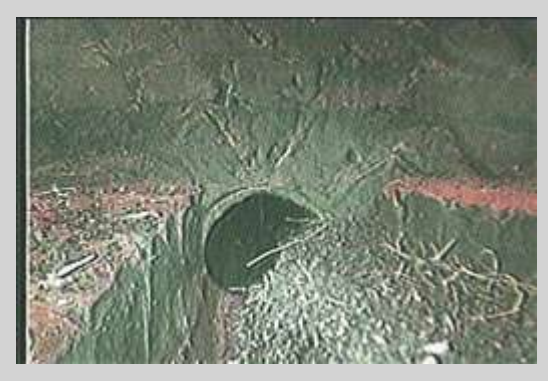
### 6 in. Circular Gravity Sewer Pipe Out @ 12 O'Clock

Barrel deterioration and infiltration.

Infiltration: **None** Pipe Seal Cond: **Roots**

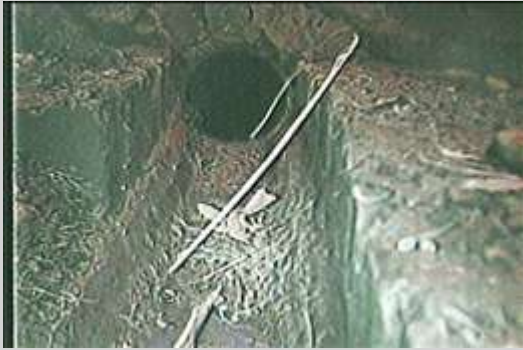
Pipe In @ 6 O'Clock

Channel root intrusion.

Infiltration: **Evidence** Pipe Seal Cond: **Roots**
